**Flood Control Project Maintenance
Levee Inspections**

Fall 2016 Levee Maintenance Deficiency Summary Report

Sacramento River Basin

| RD0150 | Overall LMA Rating | Total LMA Miles | * Overall LMA Threshold Percent is less than 10.00%; however, U Rated Miles are present, so the Overall LMA Rating is M instead of A. | | | | | |
|--|---|---|---|---|---|---|---|---|
| Reclamation District No. 0150 Merrit Island | M * | 17.74 | | | | | | |

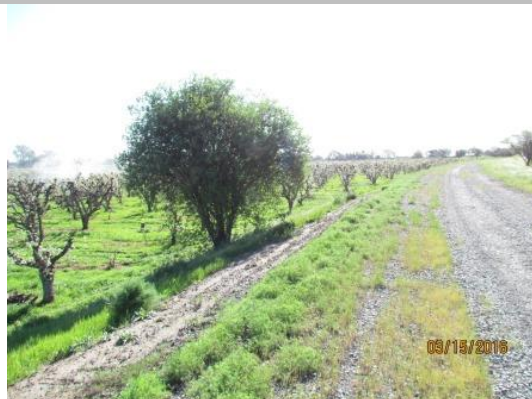
Photo 1 of 1 : FA_2016_RD0150_15_3_20160823_00003.jpg

| Elderberry is trimmed and levee slope is accessible. | | | | | |

View of the elderberry on the landside toe of the levee. The elderberry doesn't block visibility and it is trimmed up 5 feet above the slope.

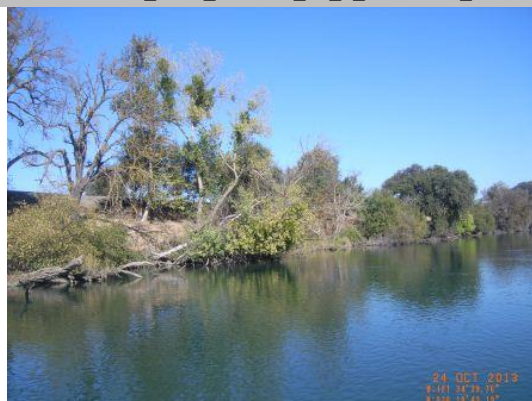
Photo 2 of 2 : FA_2016_RD0150_15_2_20160823_00002.jpg

| 2013 - Old toe repair unraveling. Bridge at upstream end of site. 2015: No observed changes. [2015 Site ID: STR_28-4_R] | | | | | |

USACE 2013 Photo #2

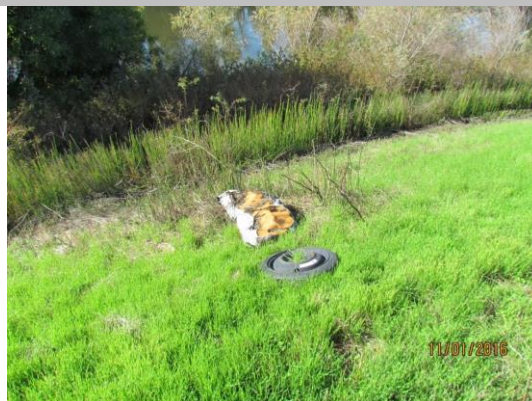
Photo 1 of 1 : FA_2016_RD0150_15_7_20161104_00005.jpg

View of debris on the waterside slope of the levee. Fall 2016

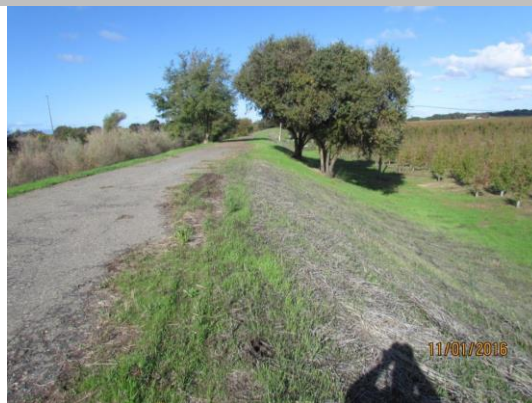
Photo 1 of 1 : FA_2016_RD0150_15_1_20161104_00004.jpg

| Acceptable vegetation | | | | | |

View of the landside slope of the levee. Fall 2016

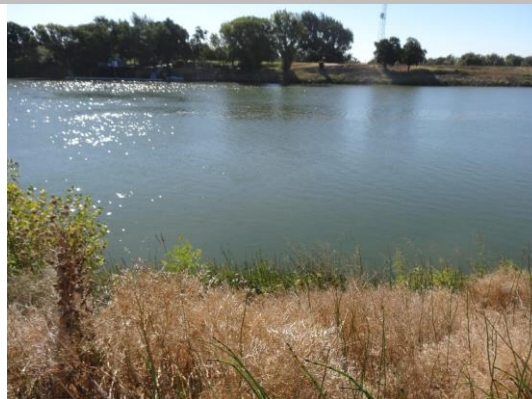
Photo 1 of 2 : UCIP_FA_2016_42700_34247.jpg

WS view: No pipe found on waterside slope. Dense vegetation on waterside.

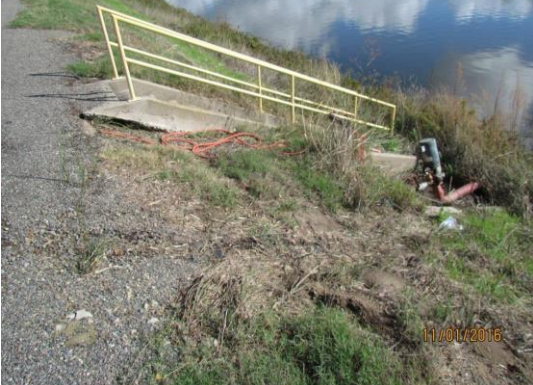
Photo 1 of 2 : FA_2016_RD0150_16_6_20161104_00118.jpg

Updated view of the slope instability on the waterside of the levee. Fall 2016.

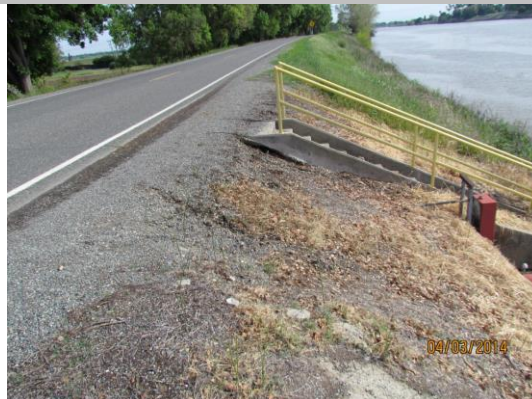
Photo 2 of 2 : FA_2016_RD0150_16_6_20160823_00003.jpg

Updated photo of the slope instability on the waterside of the levee looking upstream during spring 2014 inspection.

| S2 : Repair the levee slope damaged by foot traffic and prevent access where possible. | | | | | | |

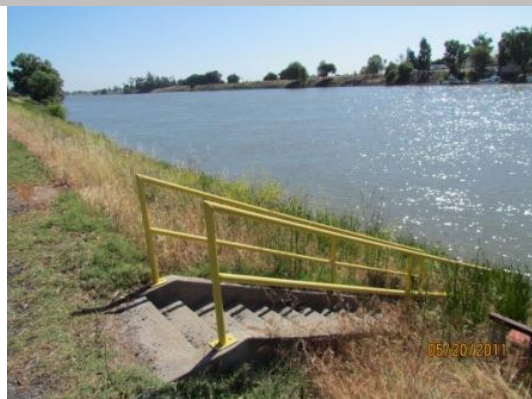
Photo 1 of 1 : FA_2016_RD0150_16_13_20160823_00009.jpg

A stairway was found on the waterside of the levee. The picture was taken from the crown looking upstream.

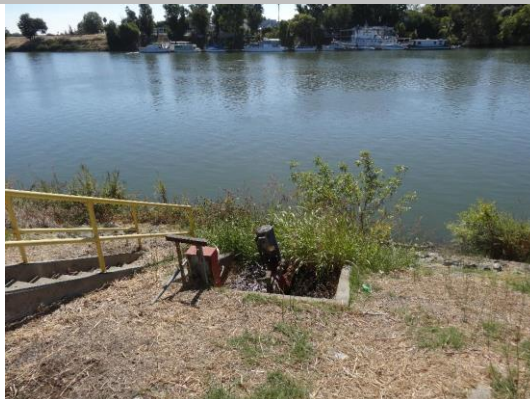
Photo 1 of 2 : UCIP_FA_2016_20268_34244.jpg

| UCIP Comments: - Water leaks from pressure breaker.- Distribution box at the landward toe not found/visible.- Service pole on LS toe. | | | | | |

WS view: walkway/stairs, pump on levee slope.

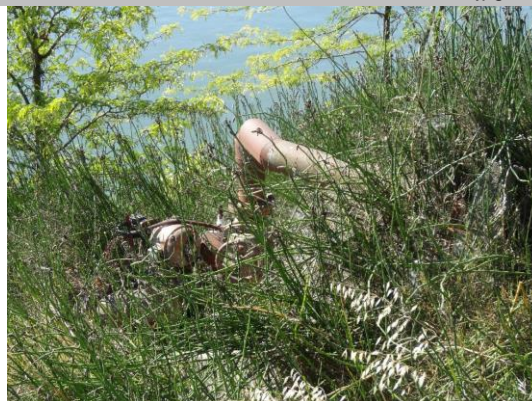
Photo 1 of 2 : UCIP_FA_2016_20267_34239.jpg

WS view: steel pipe and pump on levee slope. Dense vegetation on waterside.

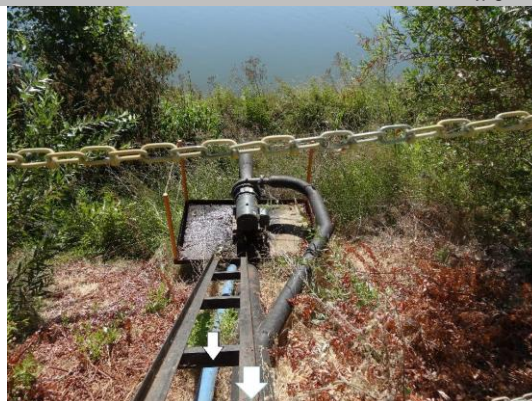
Photo 1 of 2 : UCIP_FA_2016_20303_34287.jpg

FS_ID:20303
DS_ID:22421
EP_NO: 16109
Repair Type: Non-Urgent
Crossing Status: Found
UCIP Comments: - 10" steel pipe on both sides of the levee. According to permit and inspectors note- 16" steel pipe through the levee.- concrete standpipe inside water filtration plant on landside toe.- air pressure tank on waterside steel deck.
FIELD_STRUCT_DESC: 16 inch steel pipe and 2-inch conduit through the levee, 6.2 feet below the crown, slant pump on steel platform on the waterward slope. 4-inch abandoned pipe on the waterside slope. Concrete stand pipe and power pole at landside toe. (App. No. 18258, Wilson 2007) O&M Manual SAC 112, March 1957.
FS Date: 8/27/2013

WS view: slant pump on steel deck, 4-inch pipe (left) and 10-inch pipe (right) on levee slope.

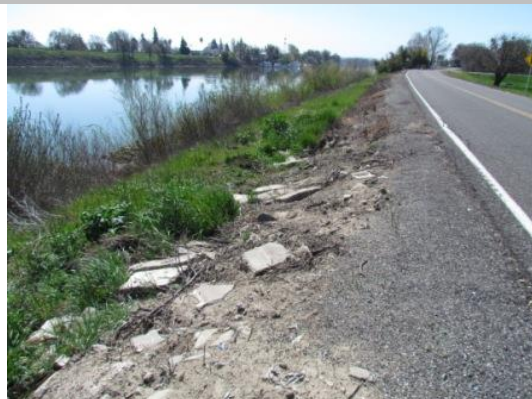
Photo 1 of 1 : FA_2016_RD0150_16_10_20160823_00007.jpg

Debris was found on the waterside slope of the levee looking downstream during Spring 2013 inspection.

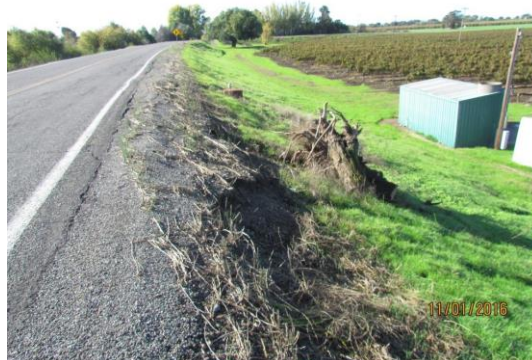
Photo 1 of 2 : FA_2016_RD0150_16_59_20161104_00117.jpg

| Damaged tree roots and trunks appear to damage landside slope of the levee. | | | | | |

Updated picture of the tree limbs and roots on the landside of the levee looking downstream. Fall 2016

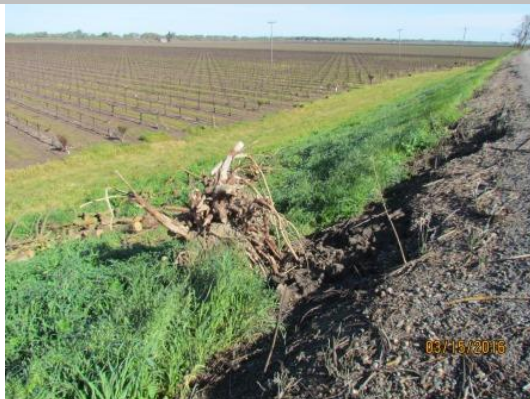
Photo 2 of 2 : FA_2016_RD0150_16_59_20160823_00034.jpg

| Damaged tree roots and trunks appear to damage landside slope of the levee. | | | | | | |

View of tree trunks and roots on the landside of the levee looking upstream.

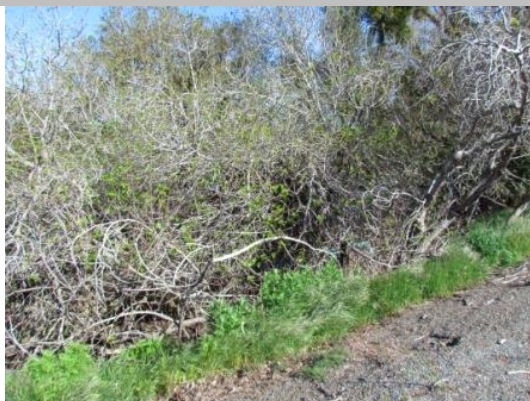
Photo 1 of 1 : FA_2016_RD0150_16_12_20160823_00008.jpg

Overgrown trees were obstructing the landside slope of the levee looking upstream.

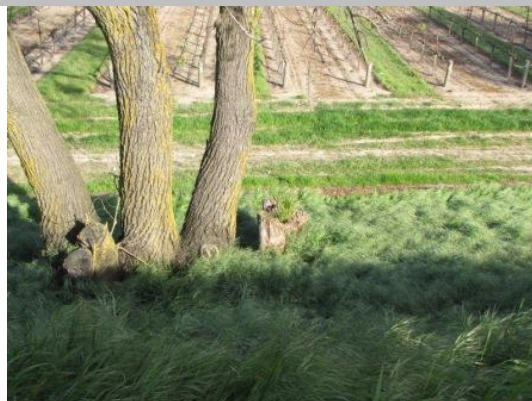
Photo 1 of 1 : FA_2016_RD0150_16_8_20160823_00005.jpg

View of a tree stump on the landward slope.

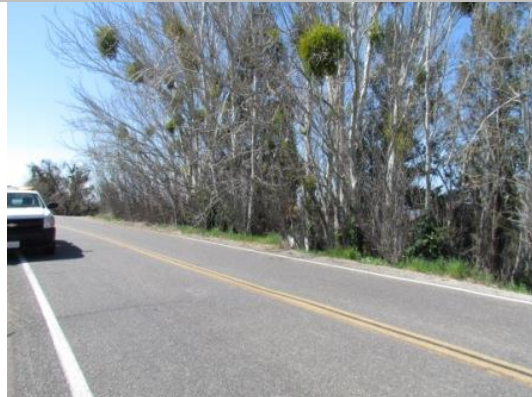
Photo 1 of 2 : FA_2016_RD0150_16_91_20160823_00047.jpg

Landscaping was obstructing the view of the landside slope of the levee looking downstream. This picture was taken during spring 2013 inspection.

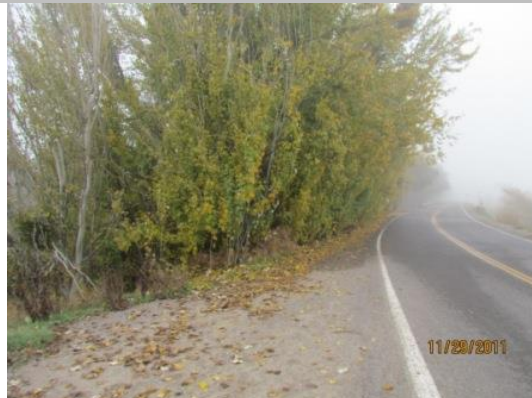
Photo 2 of 2 : FA_2016_RD0150_16_91_20160823_00048.jpg

Landscaping was found landside of the levee looking upstream.

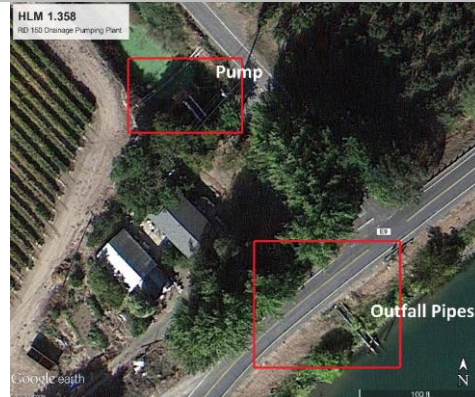
Photo 1 of 2 : UCIP_FA_2016_20727_34889.jpg

| FS_ID:20727 DS_ID:22393 EP_NO: 18221 Repair Type: Non-Urgent Crossing Status: Found UCIP Comments: Pump house and drainage ditch about 250 feet from the levee on landside.Pumps on piling structure with shed in drainage ditch.Siphon breaker cover missing. Needs to fix it. FIELD_STRUCT_DESC: 1 of 2: 30-inch pipe (of 30-inch and 24-inch steel pipes), 7.0 feet below the crown replaced 36-inch and 24-inch pipes through the levee, 9.0 and 8.0 feet below the crown respectively. Flap gates on the waterward ends. Siphon breakers on the waterward slope. Pumps on piling structure with shed in drainage ditch. (App. No. 18221 - R.D. No. 150 drainage plant). O&M Manual SAC 112, March 1957. FS Date: 8/27/2013 | | | | | |

Bird's eye view: outfall pipes (bottom) and pump structure in drainage ditch (top)

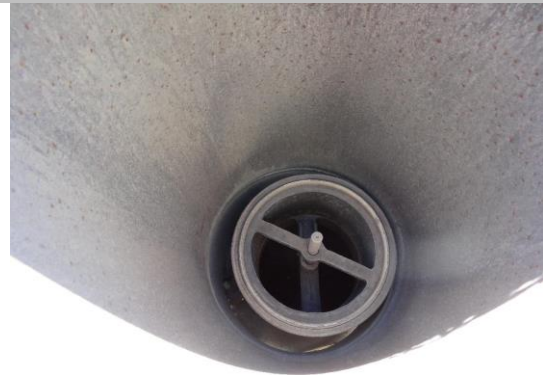
Photo 2 of 2 : UCIP_FA_2016_20727_34888.jpg

WS view: siphon breaker in pipe riser on levee shoulder.

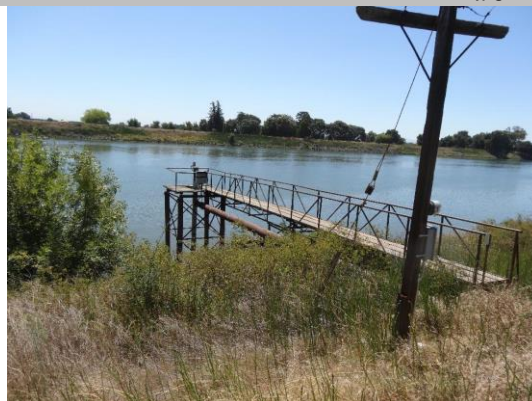
Photo 1 of 2 : UCIP_FA_2016_20348_34371.jpg

WS view: service pole, pipe & pump on piling structure in the stream.

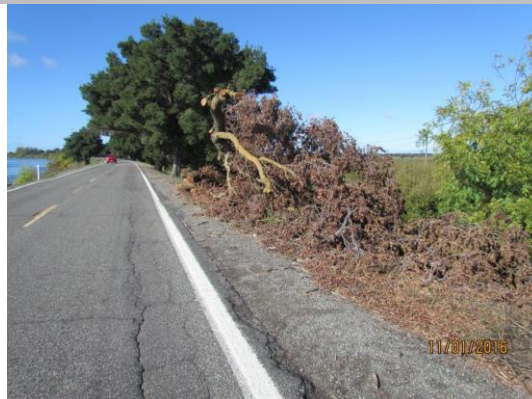
Photo 1 of 1 : FA_2016_RD0150_16_63_20161104_00116.jpg

View of prunings on landside shoulder of the levee. Fall 2016

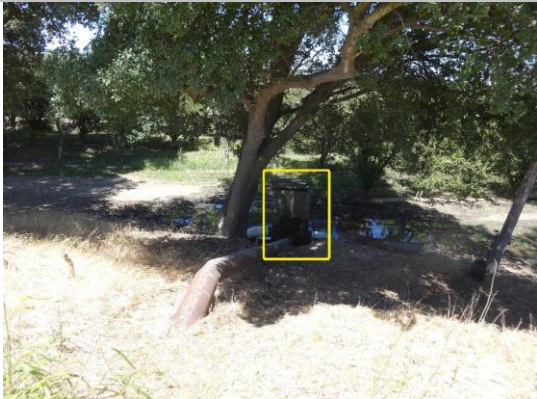
Photo 2 of 2 : UCIP_FA_2016_20731_34901.jpg

| UCIP Comments: - Operating during inspection. Leaky join at the concrete box.- Power overhead crossing. Power pole at waterside shoulder, and landside toe. | | | | | |

LS view: concrete distribution box on levee toe and exposed steel pipe on levee slope.

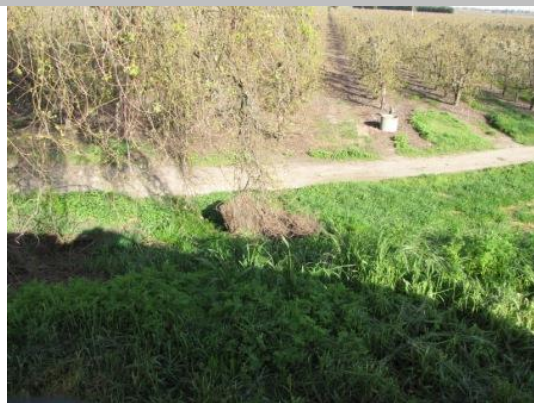
Photo 1 of 1 : FA_2016_RD0150_16_14_20160823_00010.jpg

View of a tree stump on the landward slope.

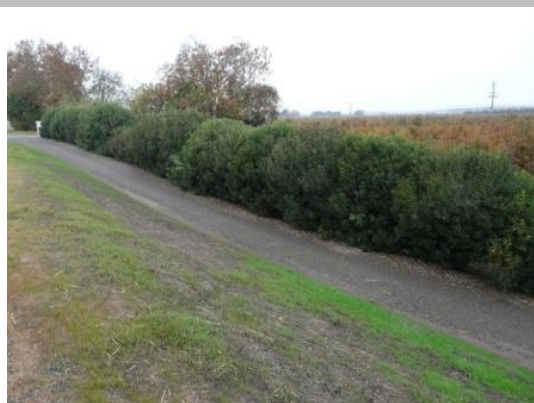
Photo 1 of 1 : FA_2016_RD0150_16_85_20160823_00045.jpg

Landscaping providing a screen for a residence on the landside of levee.

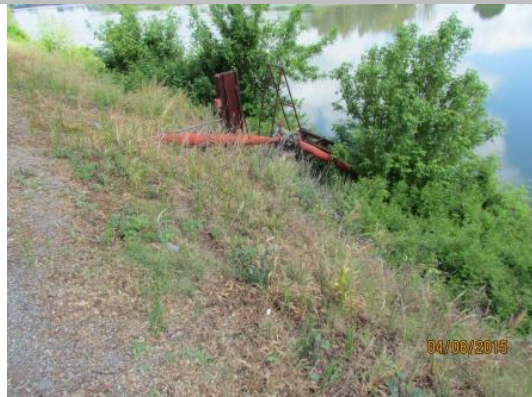
Photo 1 of 5 : FA_2016_RD0150_16_961_20160823_00050.jpg

| Depressions into the waterward slope can be seen along the waterward slope at this site. Also note the damaged pump support, pump, and pipe just upstream of the site; they may contribute to the erosion in a high water event and should be removed. | | | | | |

Updated picture of the erosion on the waterside of the levee during spring 2015 inspection.

| E2 : Schedule repair of erosion site prior to the next inspection. | | | | | |

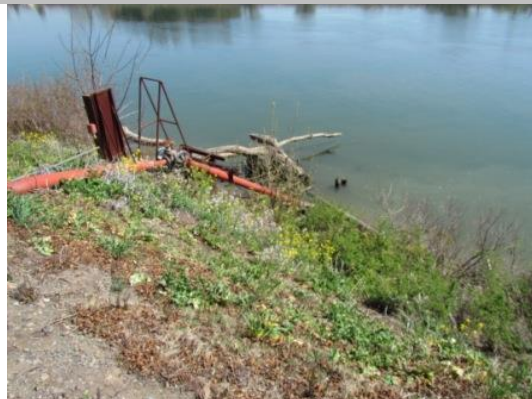
Photo 3 of 5 : FA_2016_RD0150_16_961_20160823_00052.jpg

| Depressions into the waterward slope can be seen along the waterward slope at this site. Also note the damaged pump support, pump, and pipe just upstream of the site; they may contribute to the erosion in a high water event and should be removed. | | | | | | |

View of the erosion on the waterside slope of the levee looking upstream during spring 2013 inspection.

| E2 : Schedule repair of erosion site prior to the next inspection. | | | | | | |

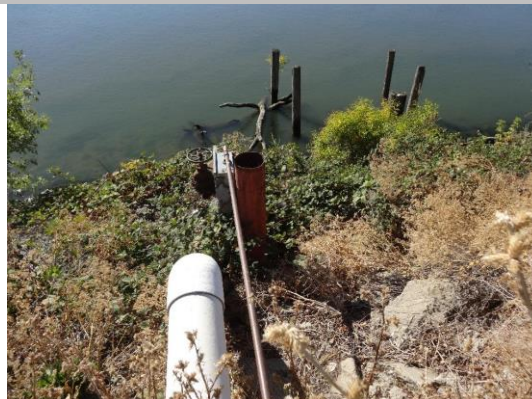
Photo 1 of 2 : UCIP_FA_2016_19846_33727.jpg

| FS_ID:19846 DS_ID:22403 EP_NO: N/A Repair Type: Non-Urgent Crossing Status: Found UCIP Comments: - 8" pvc pipe sleeved into 12" steel pipe.- needs filling/grouting in gas between 8" pvc pipe and 12" steel pipe on WS.- 1.5" electric conduit on WS- 10" steel pipe extended to 8" pvc pipe on landside levee toe. FIELD_STRUCT_DESC: 12-inch steel pipe through the levee, 3.0 feet below the crown, pump and gate valve on the waterward slope. (R & J Pylman). O&M Manual SAC 112, March 1957. FS Date: 8/30/2013 | | | | | |

WS view: pipe, pump, and conduit on levee slope.

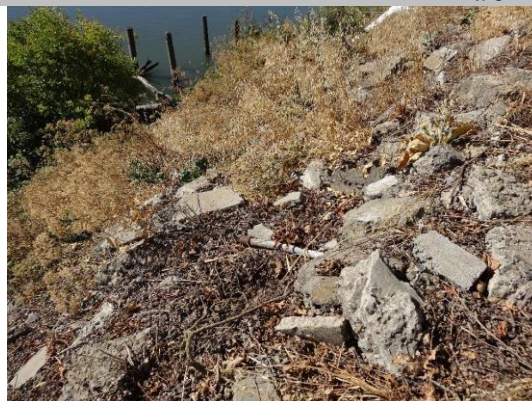
Photo 1 of 2 : UCIP_FA_2016_19848_33734.jpg

FS_ID:19848
DS_ID:22404
EP_NO: N/A
Repair Type: Non-Urgent
Crossing Status: Found
UCIP Comments: - needs proper abandonment.
FIELD_STRUCT_DESC: *ABANDONED* 4-inch steel pipe on landward slope. 1-inch steel conduit on waterward slope found.
FS Date: 8/30/2013

WS view: abandoned 1-inch conduit on levee slope.

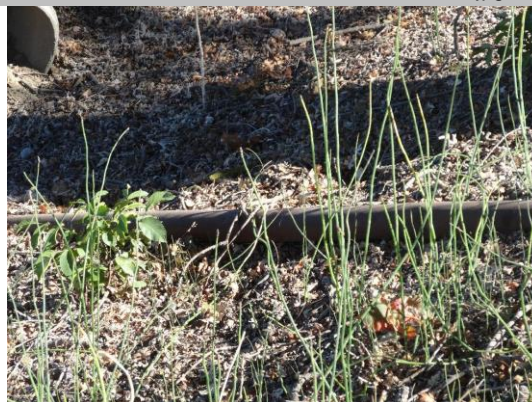
Photo 2 of 2 : UCIP_FA_2016_19848_33733.jpg

LS view: exposed 4-inch steel pipe on levee slope.

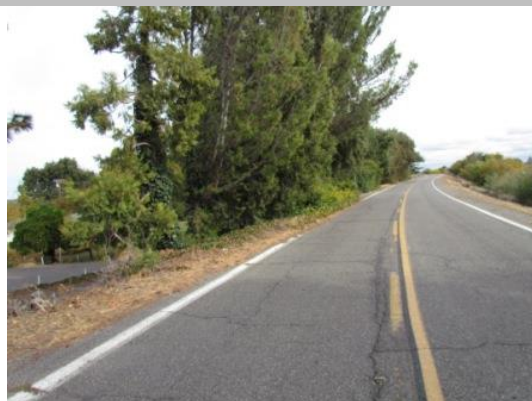
Photo 1 of 1 : FA_2016_RD0150_16_82_20160823_00044.jpg

Landscaping was blocking the visibility on the landside of the levee looking upstream.

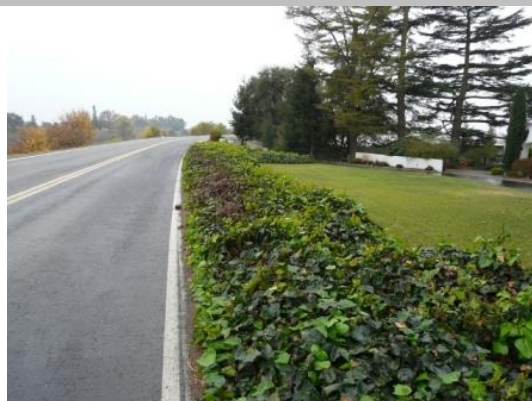
Photo 1 of 1 : FA_2016_RD0150_16_80_20160823_00043.jpg

Landscaping in front of a residence on landside of levee from LM 3.90 to LM 3.93. The levee in this location is greater than 100' wide.

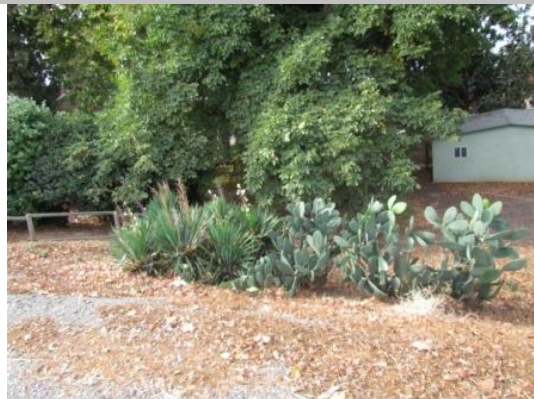
Photo 1 of 1 : FA_2016_RD0150_16_953_20160823_00049.jpg

View of cacti on the landside of the levee looking from the crown.

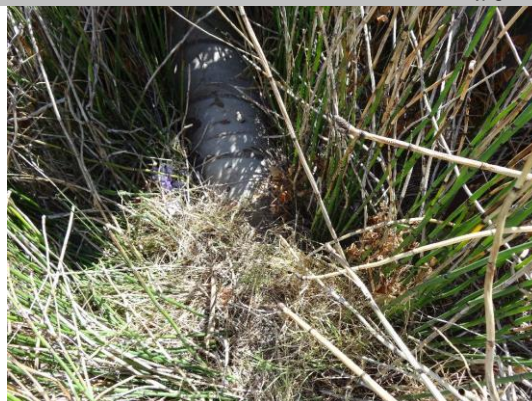
Photo 2 of 2 : UCIP_FA_2016_42702_33781.jpg

WS view: exposed 14-inch steel pipe on levee slope.

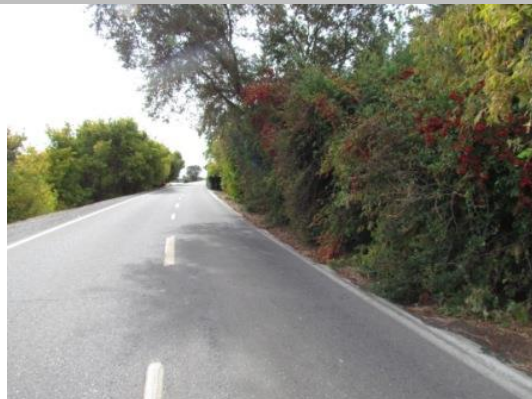
Photo 1 of 1 : FA_2016_RD0150_16_79_20160823_00042.jpg

Trees were obstructing the views on the landside slope of the levee looking downstream.

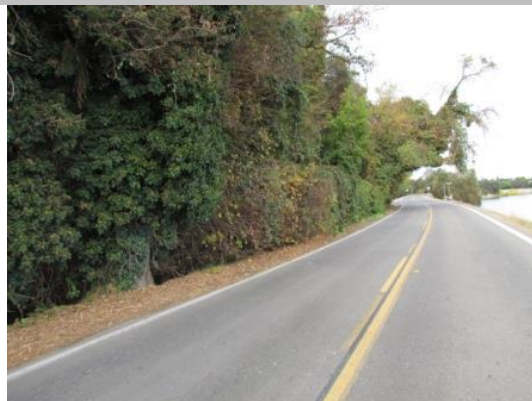
Photo 1 of 1 : FA_2016_RD0150_16_76_20160823_00041.jpg

Trees were obstructing the view of the landside slope of the levee looking upstream.

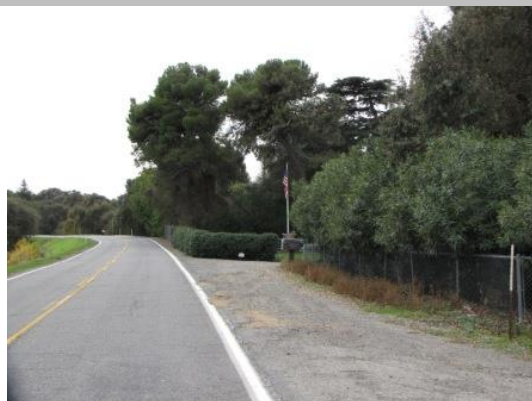
Photo 1 of 1 : FA_2016_RD0150_16_75_20160823_00040.jpg

View of landscaping along the landward shoulder and slope looking downstream.

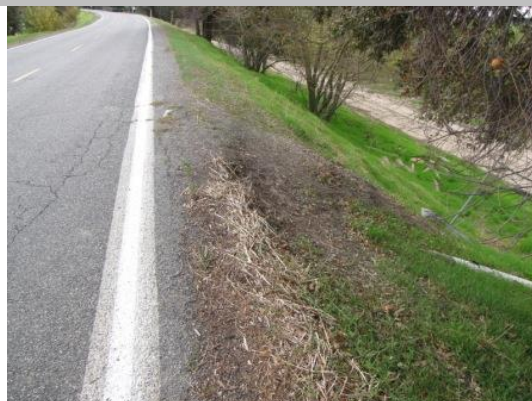
Photo 2 of 2 : FA_2016_RD0150_16_975_20160823_00056.jpg

| Depression in the waterward slope at the shoulder over an irrigation pipe. | | | | | | |

View of a minor depression along the landward slope of the levee over a pipe penetration looking downstream.

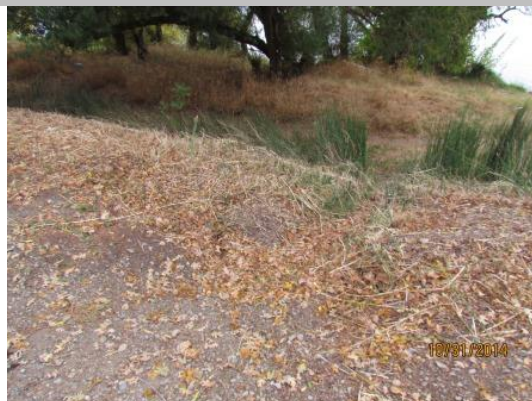
Photo 1 of 1 : FA_2016_RD0150_16_54_20160823_00029.jpg

View of a slope instability on the waterside of the levee looking towards the toe.

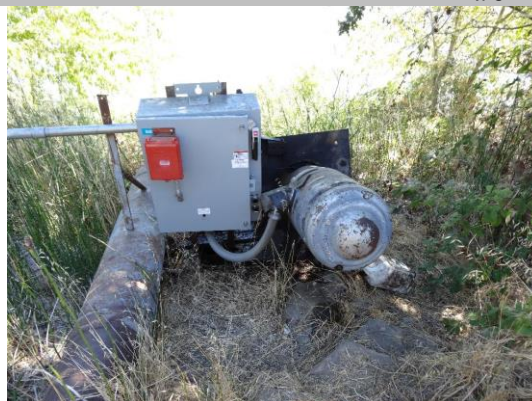
Photo 1 of 2 : UCIP_FA_2016_20748_34967.jpg

WS view: steel pipe and slant pump on levee slope.

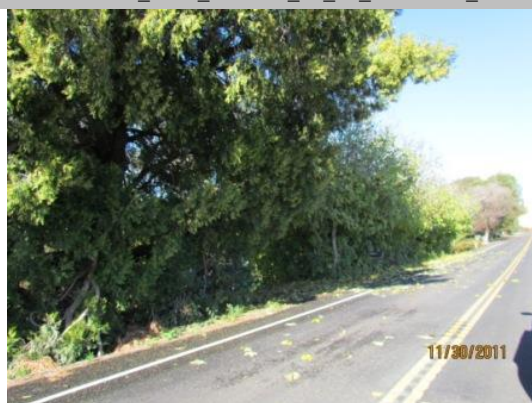
Photo 1 of 1 : FA_2016_RD0150_16_31_20160823_00019.jpg

Trees need to be trimmed on the landside of the levee looking upstream.

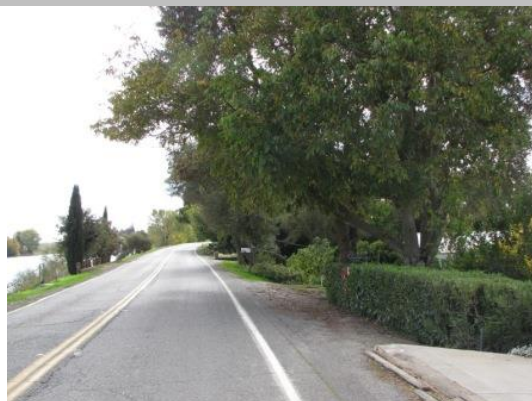
Photo 1 of 1 : FA_2016_RD0150_16_65_20160823_00038.jpg

View of landscaping along the waterward shoulder and slope looking downstream.

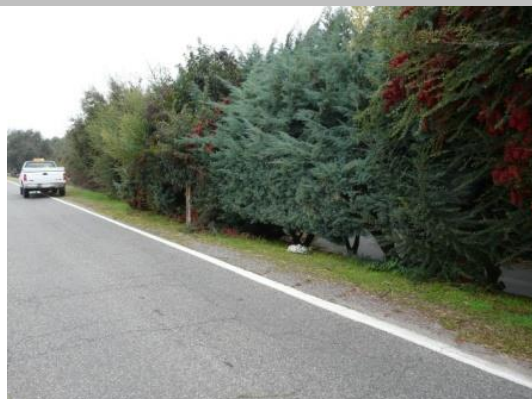
Photo 1 of 1 : FA_2016_RD0150_16_64_20160823_00037.jpg

Landscaping providing a screen for a residence on landside of levee from LM 6.68 to LM 6.72

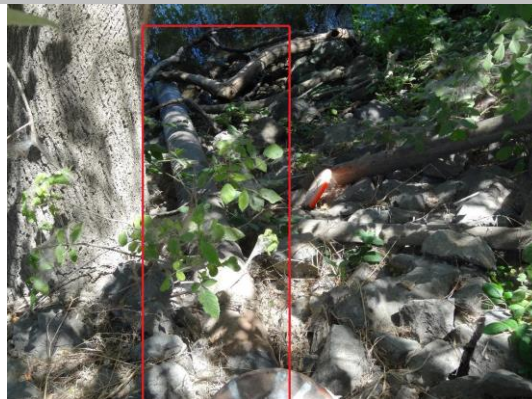
Photo 1 of 2 : UCIP_FA_2016_41646_34102.jpg

FS_ID:41646
DS_ID:22426
EP_NO: N/A
Repair Type: Non-Urgent
Crossing Status: Found
UCIP Comments: - abandoned very old gate valve also found on WS.
Rest of pipe should be evaluated due to its age.
FIELD_STRUCT_DESC: 9-inch steel irrigation pipe 9.7 feet below the crown, gate valve and pump house on the landside (LS). (Permit No. 8551, 1973 - Souza). O&M Manual SAC 112, March 1957.
FS Date: 8/30/2013

WS view: inlet steel pipe on stream bank.

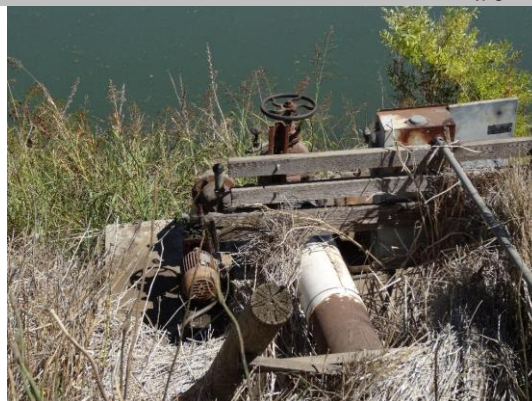
Photo 1 of 2 : UCIP_FA_2016_50387_35002.jpg

| FS_ID:50387 DS_ID:22427 EP_NO: 1703 Repair Type: Urgent Crossing Status: Found UCIP Comments: - significant erosion along pipe alignment on LS slope.- pump on concrete pad- service pole on LS slope. FIELD_STRUCT_DESC: 12-inch steel pipe through the levee, 4.5 feet below the crown, pump and gate valve on the waterward slope. Service pole and standpipe on the landward shoulder. (App. No. 1703 - M. Silva). Landowner is Craig Silva 916-396-4651, 916-876-6362. Jim Pileman (leasing land and farming it) FS Date: 8/30/2013 | | | | | |

WS view: steel pipe, electric conduit, gate valve, and pump on levee slope.

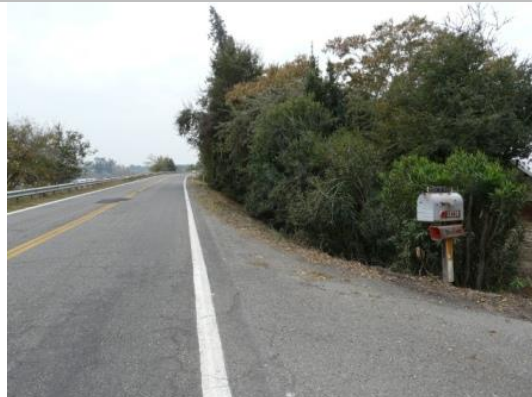
Photo 1 of 1 : FA_2016_RD0150_16_60_20160823_00035.jpg

Landscaping providing a screen for a residence on the landside of levee from LM 6.93 to LM 7.05

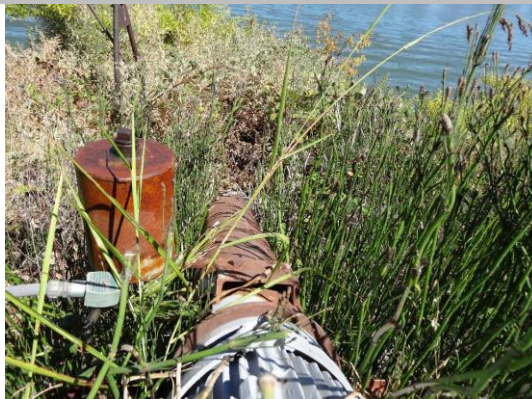
Photo 2 of 2 : UCIP_FA_2016_50386_34161.jpg

| FS_ID:50386 DS_ID:22429 EP_NO: N/A Repair Type: Urgent Crossing Status: Found UCIP Comments: - soil erosion along pipe alignment on LS slope.- needs more investigation and mitigation for soil erosion. FIELD_STRUCT_DESC: 8-inch steel pipe through the levee 10.0 feet below the crown, pump on concrete slab and slide gate in CMP riser on the waterward slope. Pipe through the levee section encased in reinforced concrete. A concrete standpipe on landside toe. (A. Monice). Landowner is Steve Winkler 916-599-1052. FS Date: 8/30/2013 | | | | | |

WS view: steel intake pipe and pump on levee slope. Dense vegetation on levee slope.

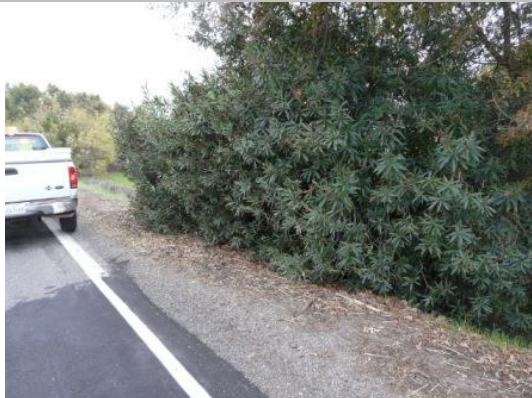
Photo 1 of 1 : FA_2016_RD0150_16_58_20160823_00033.jpg

Landscaping providing a screen for a residence on landside of levee at LM 7.12

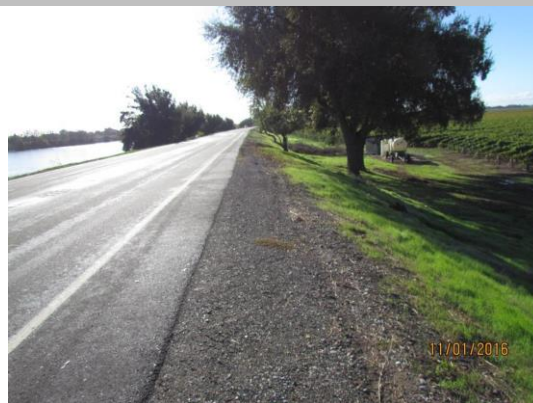
Photo 1 of 1 : FA_2016_RD0150_16_51_20161104_00113.jpg

View of landside slope of the levee. Fall 2016

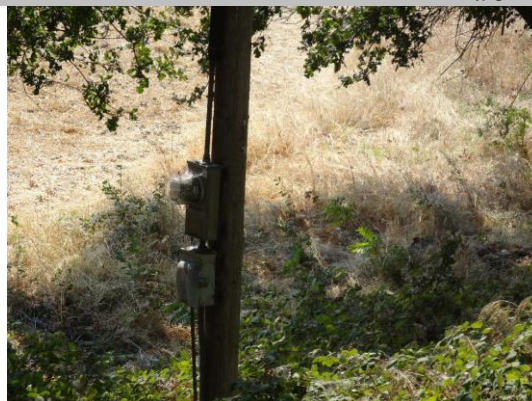
Photo 1 of 2 : UCIP_FA_2016_42693_31979.jpg

FS_ID:42693
DS_ID:22454
EP_NO: N/A
Repair Type: Non-Urgent
Crossing Status: Found
UCIP Comments: Seems to be abandoned. Service pole on LS slope.

LS view: service pole on levee slope.

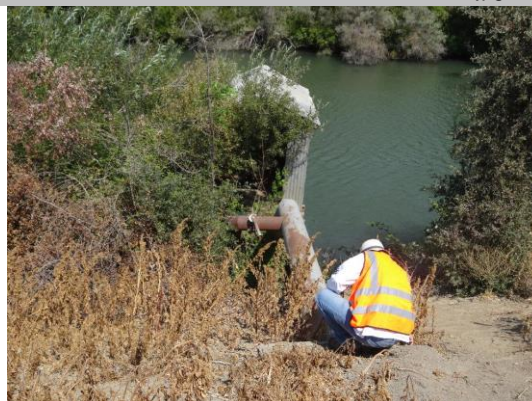
Photo 1 of 2 : UCIP_FA_2016_19112_32044.jpg

FS_ID:19112
DS_ID:22433
EP_NO: N/A
Repair Type: Non-Urgent
Crossing Status: Found
UCIP Comments: No handrail on wooden walkway.
FIELD_STRUCT_DESC: 14-inch steel pipe through the levee, 8.0 feet below the crown, pump in pump house on the waterward slope. Service pole and steel distribution box on the landward slope.
FS Date: 8/20/2013

WS view: pipe on levee slope and pump house in channel.

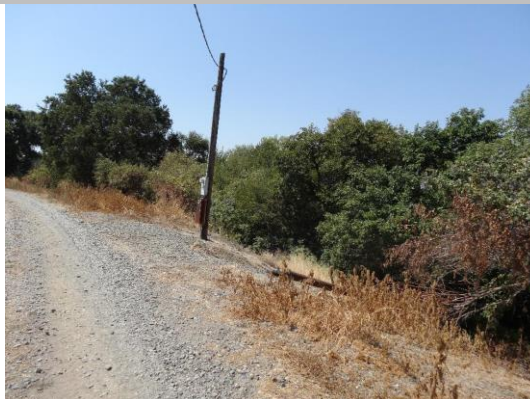
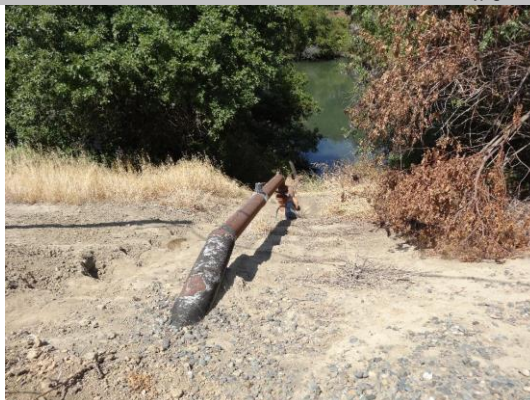
| FS_ID:19137 DS_ID:22434 EP_NO: N/A Repair Type: Non-Urgent Crossing Status: Found UCIP Comments: Small depression on WS slope due to leak from pump. Pipe opens on LS ditch/depression. FIELD_STRUCT_DESC: 10-inch pipe through the levee, 3.4 feet below the crown, pump, gate valve and service pole on the waterward slope. FS Date: 8/20/2013 | | | | | |

WS view: exposed pipe and power pole on levee slope.

WS view: exposed pipe on levee slope.

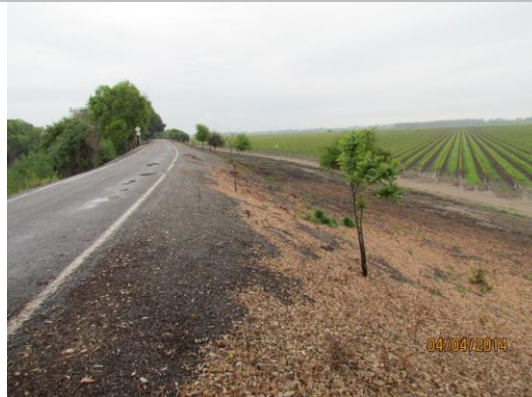
Photo 2 of 4 : FA_2016_RD0150_17_78_20160823_00070.jpg

View of the newly planted tree on the landside slope of the levee during spring 2014 inspection.

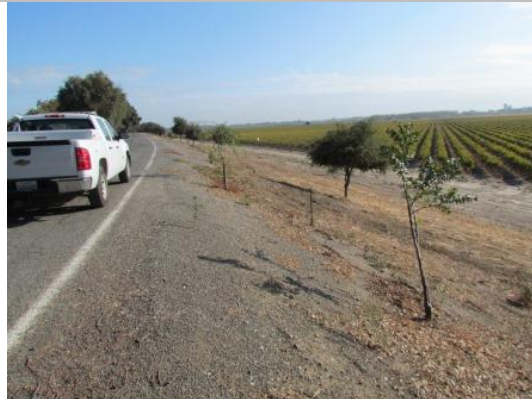
Photo 3 of 4 : FA_2016_RD0150_17_78_20160823_00071.jpg

Several newly planted trees were found on the landside slope of the levee looking upstream during the fall 2013 inspection.

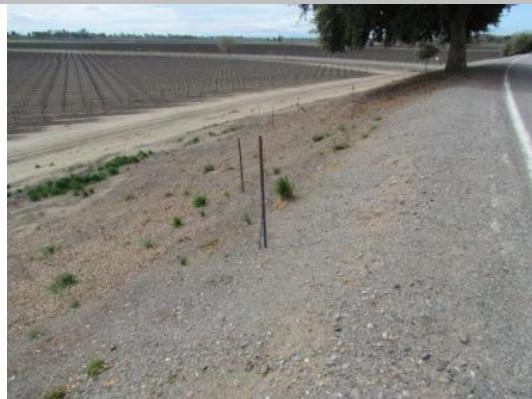
Photo 4 of 4 : FA_2016_RD0150_17_78_20160823_00072.jpg

New tree was planted on the landside of the levee looking downstream.

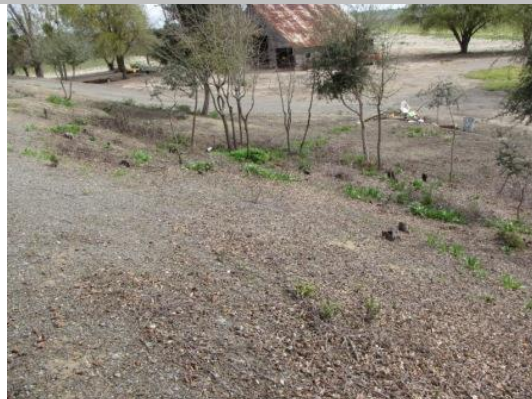
Photo 1 of 1 : FA_2016_RD0150_17_11_20160823_00008.jpg

View of tree stumps on the landward slope.

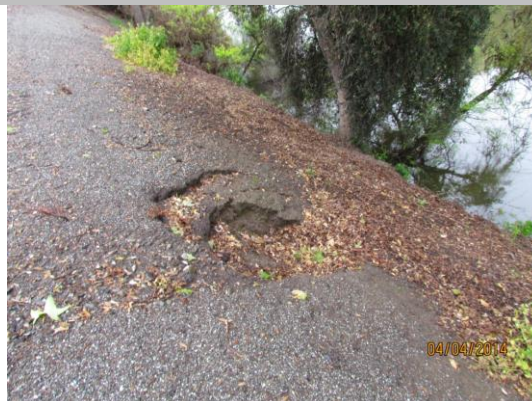
Photo 2 of 2 : FA_2016_RD0150_17_35_20160823_00029.jpg

Updated picture of the erosion on the waterside slope of the levee during spring 2014 inspection.

| E2 : Schedule repair of erosion site prior to the next inspection. | | | | | |

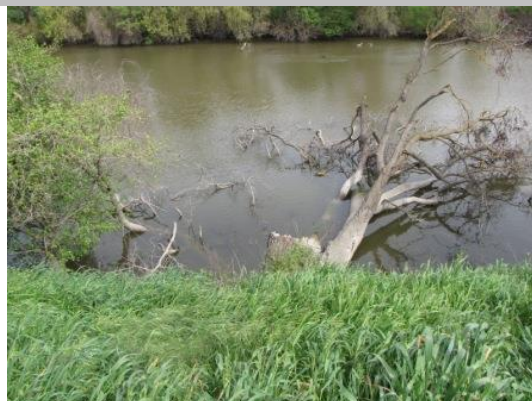
Photo 1 of 1 : FA_2016_RD0150_17_20_20160823_00016.jpg

View of tree stumps on the waterward slope.

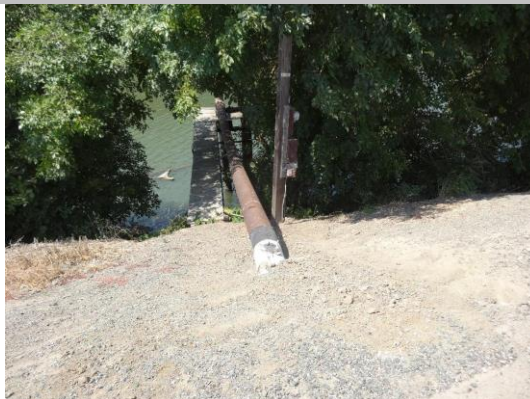
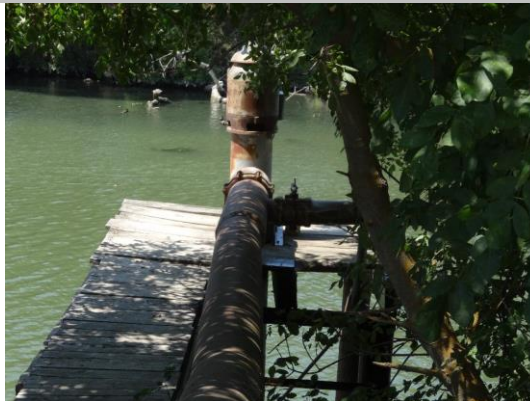
| FS_ID:50672 DS_ID:22439 EP_NO: N/A Repair Type: Urgent Crossing Status: Found UCIP Comments: 11/10/2016 Erosion at LS toe has progressed since last inspection and is now severe. Photo courtesy of Pavel Kazi, FPIIB Inspector, as a part of his Fall 2016 Inspections. Crossing has been upgraded from Non-Urgent to Urgent. (K. Fazel - UCIP)08/20/2013 Leaky concrete standpipe on landside levee toe creating some erosion.- pump was working at the time of inspection. (P. Amatya - DWR) FIELD_STRUCT_DESC: 8-inch steel irrigation pipe through the levee, 3.7 feet below the crown. Service pole on the waterside (WS) slope and pump on piling in the stream. Concrete stand pipe on landside (LS) toe. [Additional References: DWR Levee Log, 2005. USACE Sacramento O&M Manual 112, March 1957 (RM 3.45)]. FS Date: 11/10/2016 | | | | | |

WS view: exposed pipe, walkway, service pole on levee slope and pump support in channel.

WS view: steel pipe & pump, walkway, pump support in the channel.

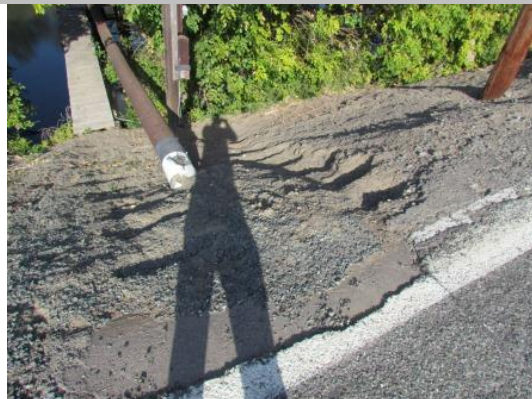
Photo 1 of 1 : FA_2016_RD0150_17_114_20160823_00092.jpg

View of steps that were dug on the waterside slope of the levee looking upstream.

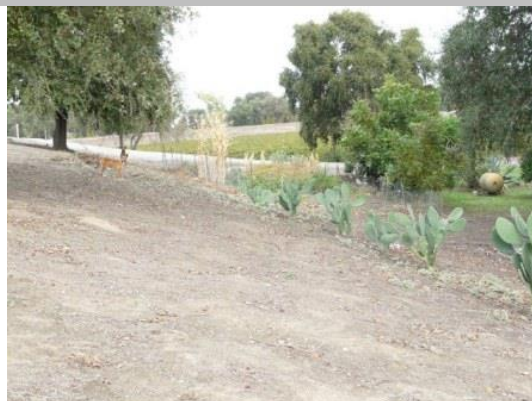
Photo 1 of 1 : FA_2016_RD0150_17_47_20160823_00038.jpg

Landscaping & garden on landward slope of levee at LM 3.50 to LM 3.54.

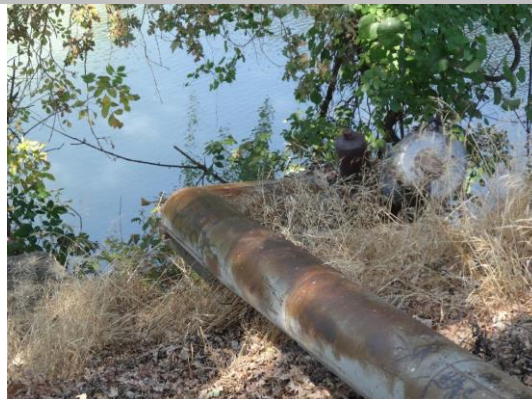
Photo 1 of 2 : UCIP_FA_2016_50202_35018.jpg

WS view: steel pipe and pump on levee slope.

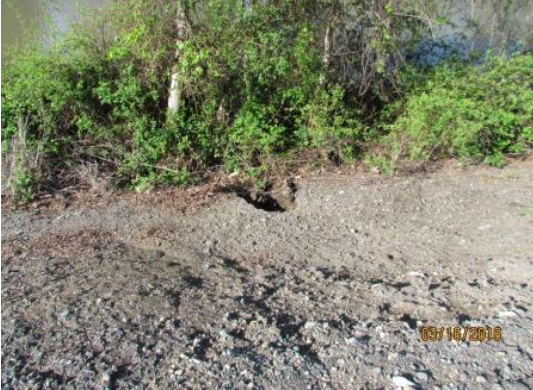
Photo 1 of 1 : FA_2016_RD0150_17_g3_20160823_00086.jpg

View of slope instability on the waterside of the levee. Fall 2016

An erosion was found on the waterside toe of the levee.

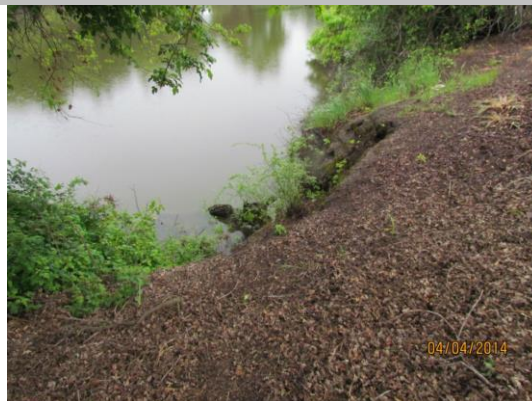
Photo 1 of 1 : FA_2016_RD0150_17_80_20160823_00073.jpg

View of an erosion site on the waterside toe of the levee looking upstream.

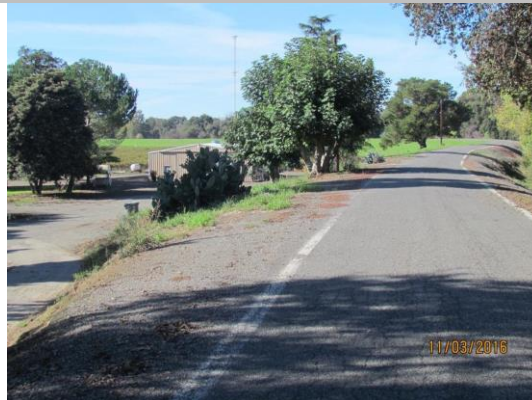
Photo 1 of 1 : FA_2016_RD0150_17_94_20161104_00148.jpg

View of landscape on the landside shoulder of the levee.

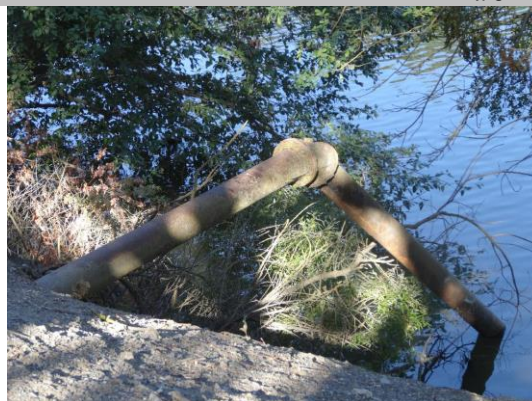
Photo 1 of 2 : UCIP_FA_2016_19283_32565.jpg

WS view: steel pipe on levee slope and in the stream.

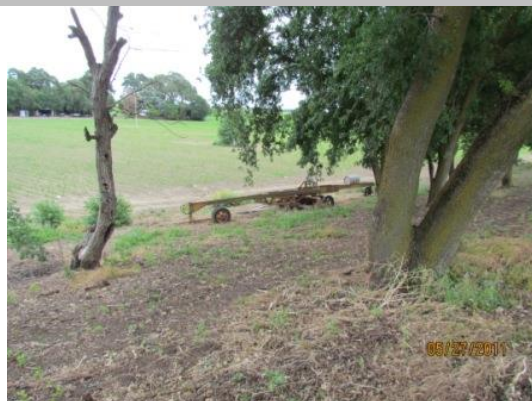
Photo 1 of 1 : FA_2016_RD0150_17_9_20160823_00007.jpg

Equipment on the landside toe of the levee. The picture was taken from crown looking downstream.

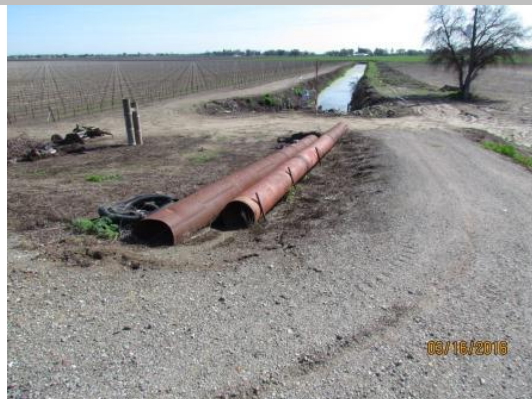
| Abandoned pipe was found on the landside slope of the levee. | | | | | |

View of an abandoned pipe on the landside slope of the levee.

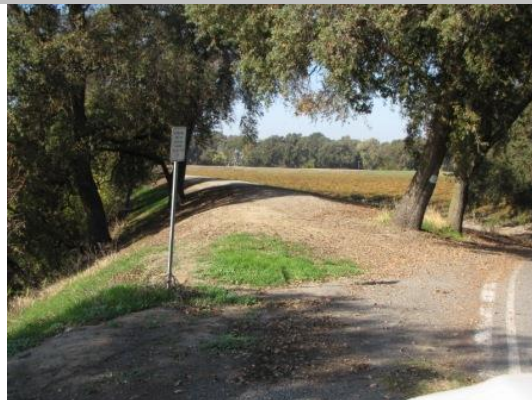
| There is a significant difference in the crown roadway elevation as it transitions from the paved roadway to the gravel access road. | | | | | |

View of varying elevations in the crown of the levee at the transition from county road to access road.

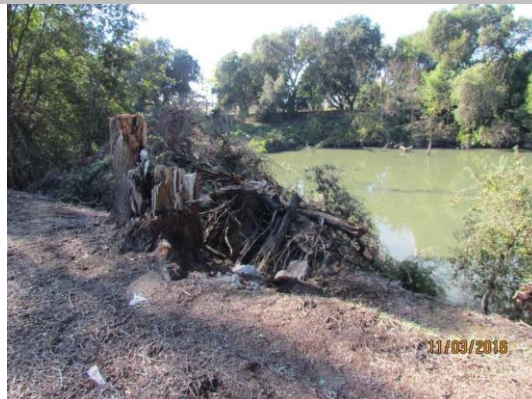
Photo 1 of 1 : FA_2016_RD0150_17_74_20161104_00150.jpg

| Tree stump and broken tree was found on the waterside shoulder of the levee. | | | | | |

View of tree trunks on the waterside shoulder of the levee. Fall 2016

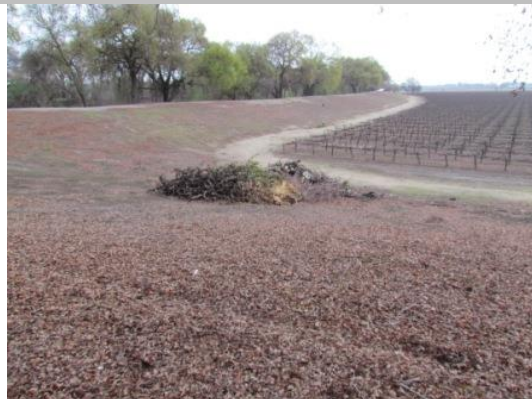
Photo 1 of 2 : FA_2016_RD0150_17_12_20160823_00009.jpg

Prunings were found on the landside of the levee looking upstream.

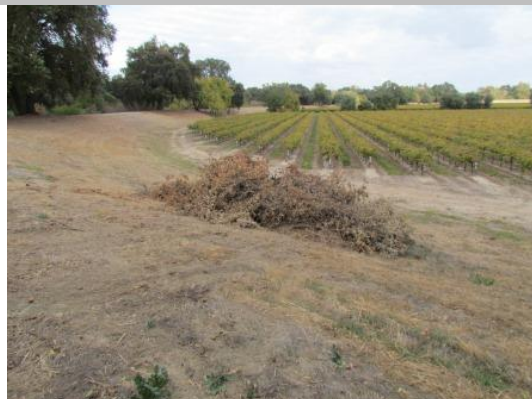
Photo 2 of 2 : FA_2016_RD0150_17_12_20160823_00010.jpg

Updated picture of pruning pile on the landside toe of the levee looking upstream during the fall 2013 inspection.

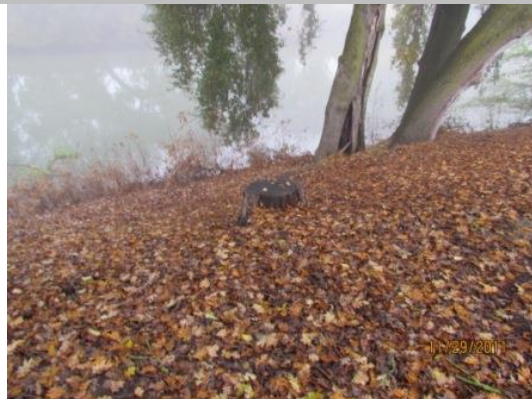
Photo 1 of 1 : FA_2016_RD0150_17_68_20160823_00064.jpg

Tree stump was found on the waterside of the levee looking upstream.

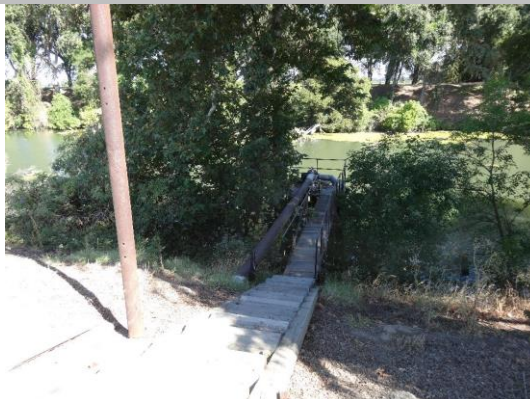
Photo 1 of 2 : UCIP_FA_2016_28265_51974.jpg

WS view: walkway, pipe, pump and support deck on river bank.

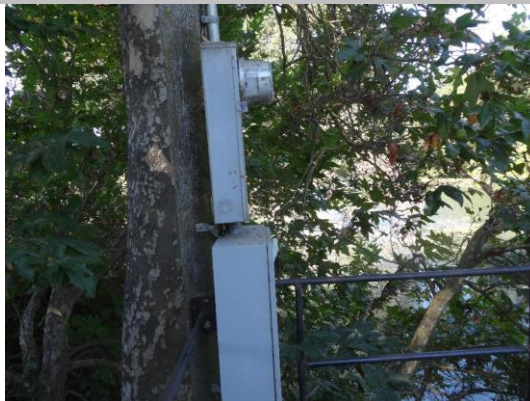
Photo 2 of 2 : UCIP_FA_2016_28265_51973.jpg

WS view: electric control box and power pole.

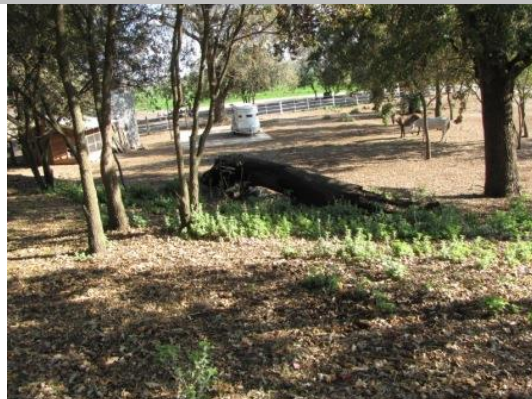
Photo 1 of 1 : FA_2016_RD0150_17_57_20160823_00050.jpg

View of a tree trunk lying on the landward slope blocking visibility.

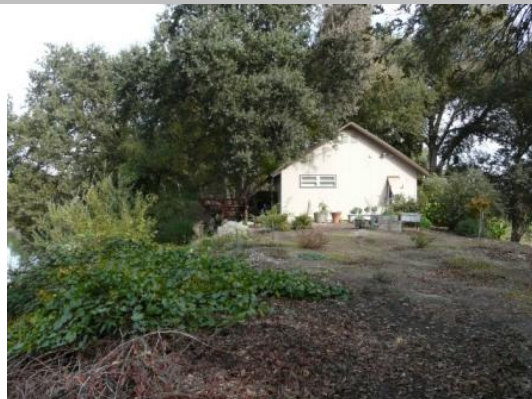
Photo 1 of 1 : FA_2016_RD0150_17_58_20160823_00051.jpg

| Permit 7517-A covers this area, but more research is needed. | | | | | |

Building & associated landscaping on levee crown.

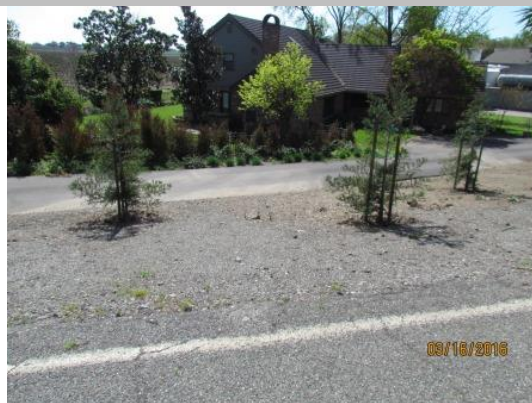
Photo 1 of 1 : FA_2016_RD0150_17_99_20160823_00091.jpg

| Newly planted tree on the landside slope of the levee. | | | | | |

View of newly planted tree on the landside slope of the levee.

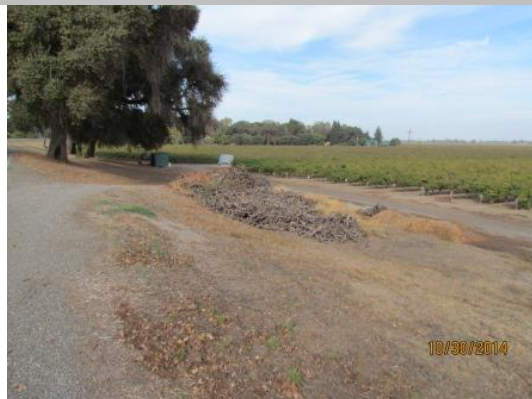
Photo 1 of 1 : FA_2016_RD0150_17_83_20160823_00076.jpg

Prunings were found on the landside toe of the levee looking upstream.

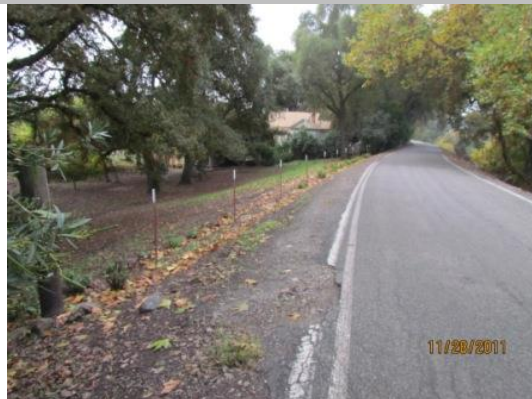
Photo 1 of 1 : FA_2016_RD0150_17_13_20160823_00013.jpg

Fence was found on the landside of the levee looking downstream.

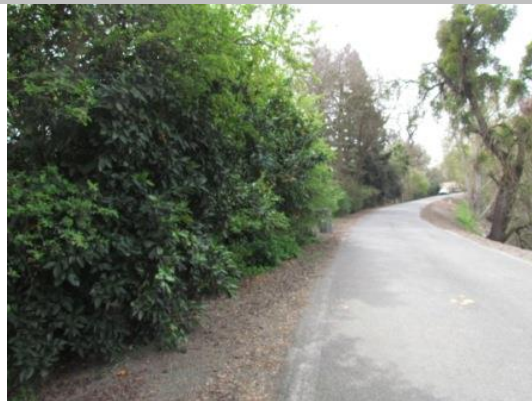
Photo 1 of 1 : FA_2016_RD0150_17_933_20160823_00097.jpg

| Landscaping has been maintained better, but some obstructions still exist. | | | | | |

View of the landscape on the landside shoulder of the levee looking downstream.
